ROCKINGER

RO400B52001

40mm Easy Mount Towing Coupling

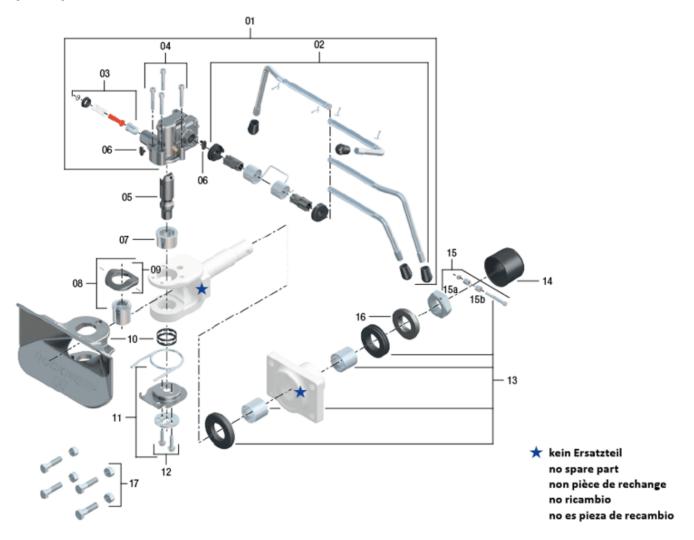
Spare parts

Fig	Description	Part No
01	Head & Handle assembly	ROE71448B
02	Handle down	ROE71795B
03	Safety system	ROE71491
04	Screw set	ROE30361
05	Coupling pin	ROE47099
06	Flap	ROE25558
07	Bush	ROE53520
80	Bush with support ring	ROE71718
09	Support ring	ROE59415

Fig	Description	Part number
10	Funnel	ROE46109
11	Base plate compl.	ROE71331
12	Screw set	ROE30486
13	Repair kit bearing incl. 15b	ROE71962
14	Сар	ROE25704
15	Nut	ROE71796
16	Conical plate	ROE59478
17	Screw set x-member thickness ≤ 22 mm	ROE71957
17	Screw set x-member thickness ≥ 23-35mm	ROE59466

Fig.	Repair Kit Description	Part No
03,05,07,08,11	Repair kit	ROE71728
